**PHASE II ENVIRONMENTAL  
SITE ASSESSMENT  
144 MONTELLO ST  
LEWISTON, MAINE**

October 27, 2009  
Project # 16966

**PHASE II ENVIRONMENTAL SITE ASSESSMENT  
144 MONTELLO ST  
LEWISTON, MAINE**

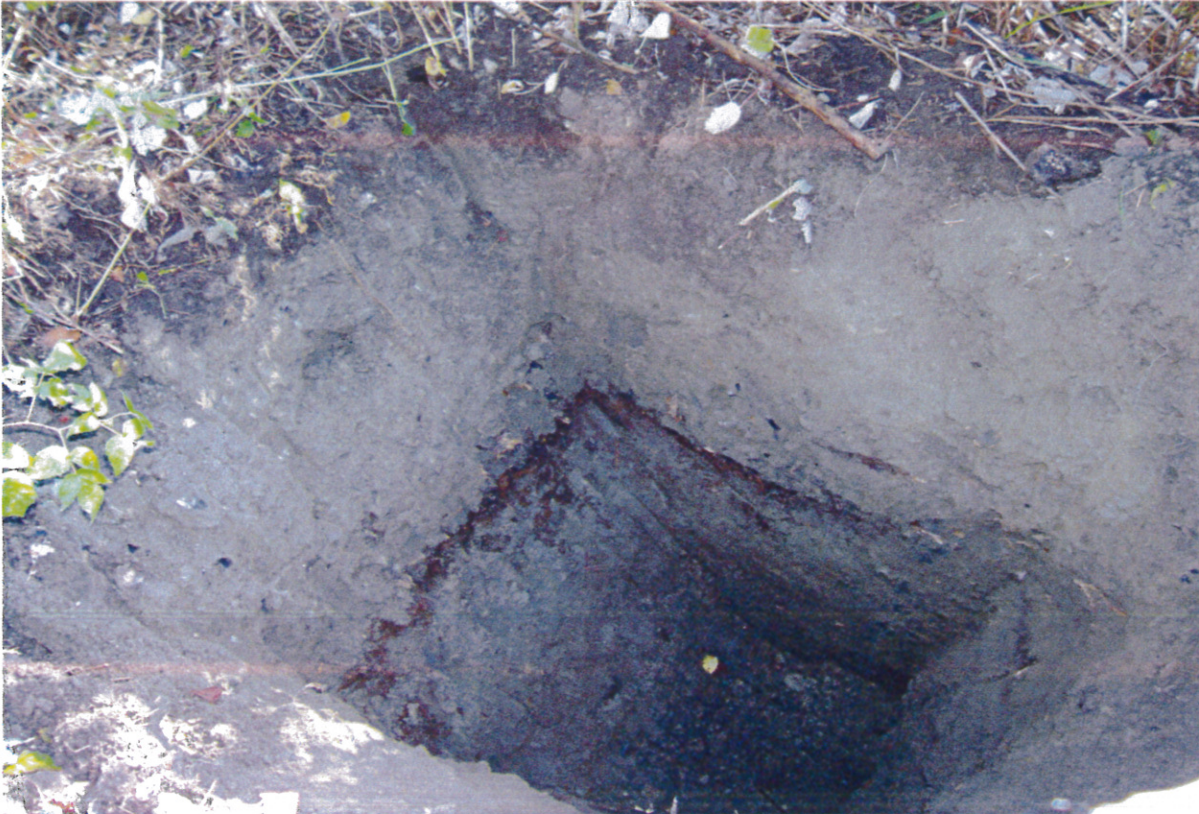
**Test Pit A**

Analytical results reported the presence of PAHs in each of the test pit samples. The greatest number and highest concentrations of PAHs were reported in test pits A and C. Test pits B, D and E had fewer PAHs at lower concentrations. Five specific PAH compounds in samples TP-A and four PAH compounds in TP-C were reported above their respective RAG target concentration.

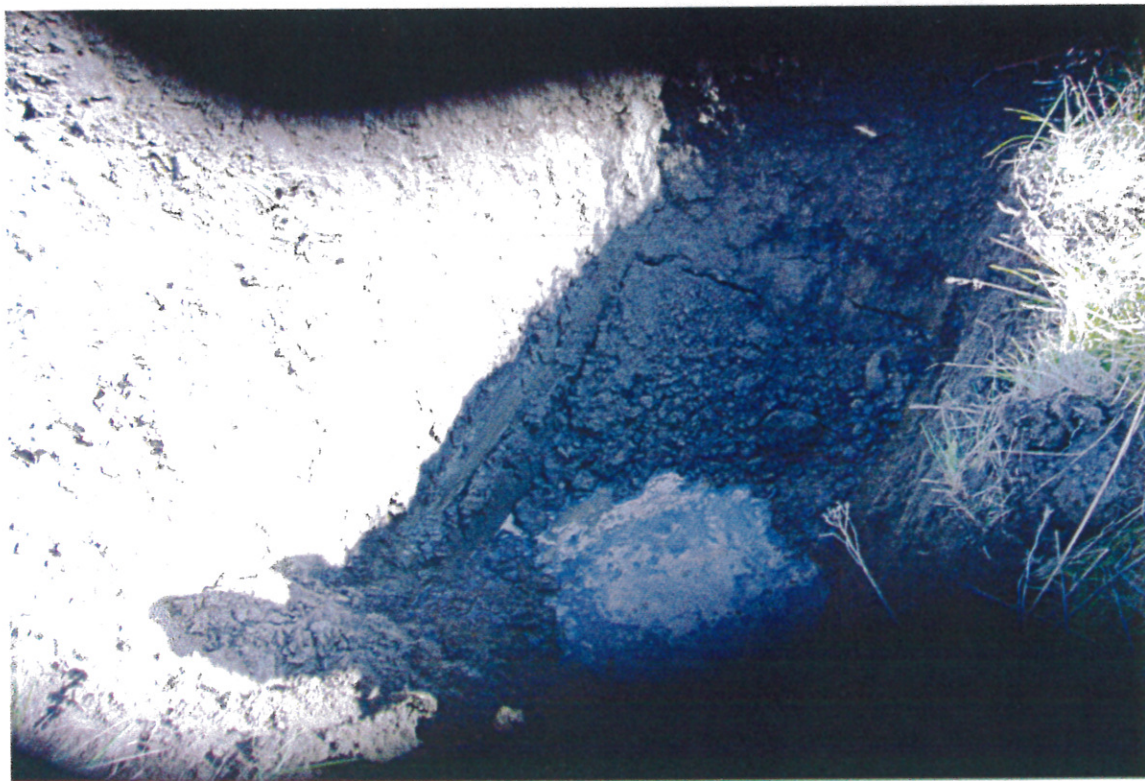
**Test Pit D**

Geologic data collected from test pit excavations, along with visual observations of site topography are consistent with the Conceptual Site Model. A gray fine sand and silt Fill with occasional rocks and boulders is present from ground surface to depths of 4.5 feet. Small quantities of asphalt, concrete and brick were observed in the Fill. A black seam of sandy material (possibly ash) was observed in test pit TP-D.
